REPORT NO. 1143

BOMBS AND ASSOCIATED COMPONENTS

-----  
COLD WEATHER TESTING OF BOMB,  
EX 14 MOD 0 (FIRE-1000 LBS)

FINAL Report

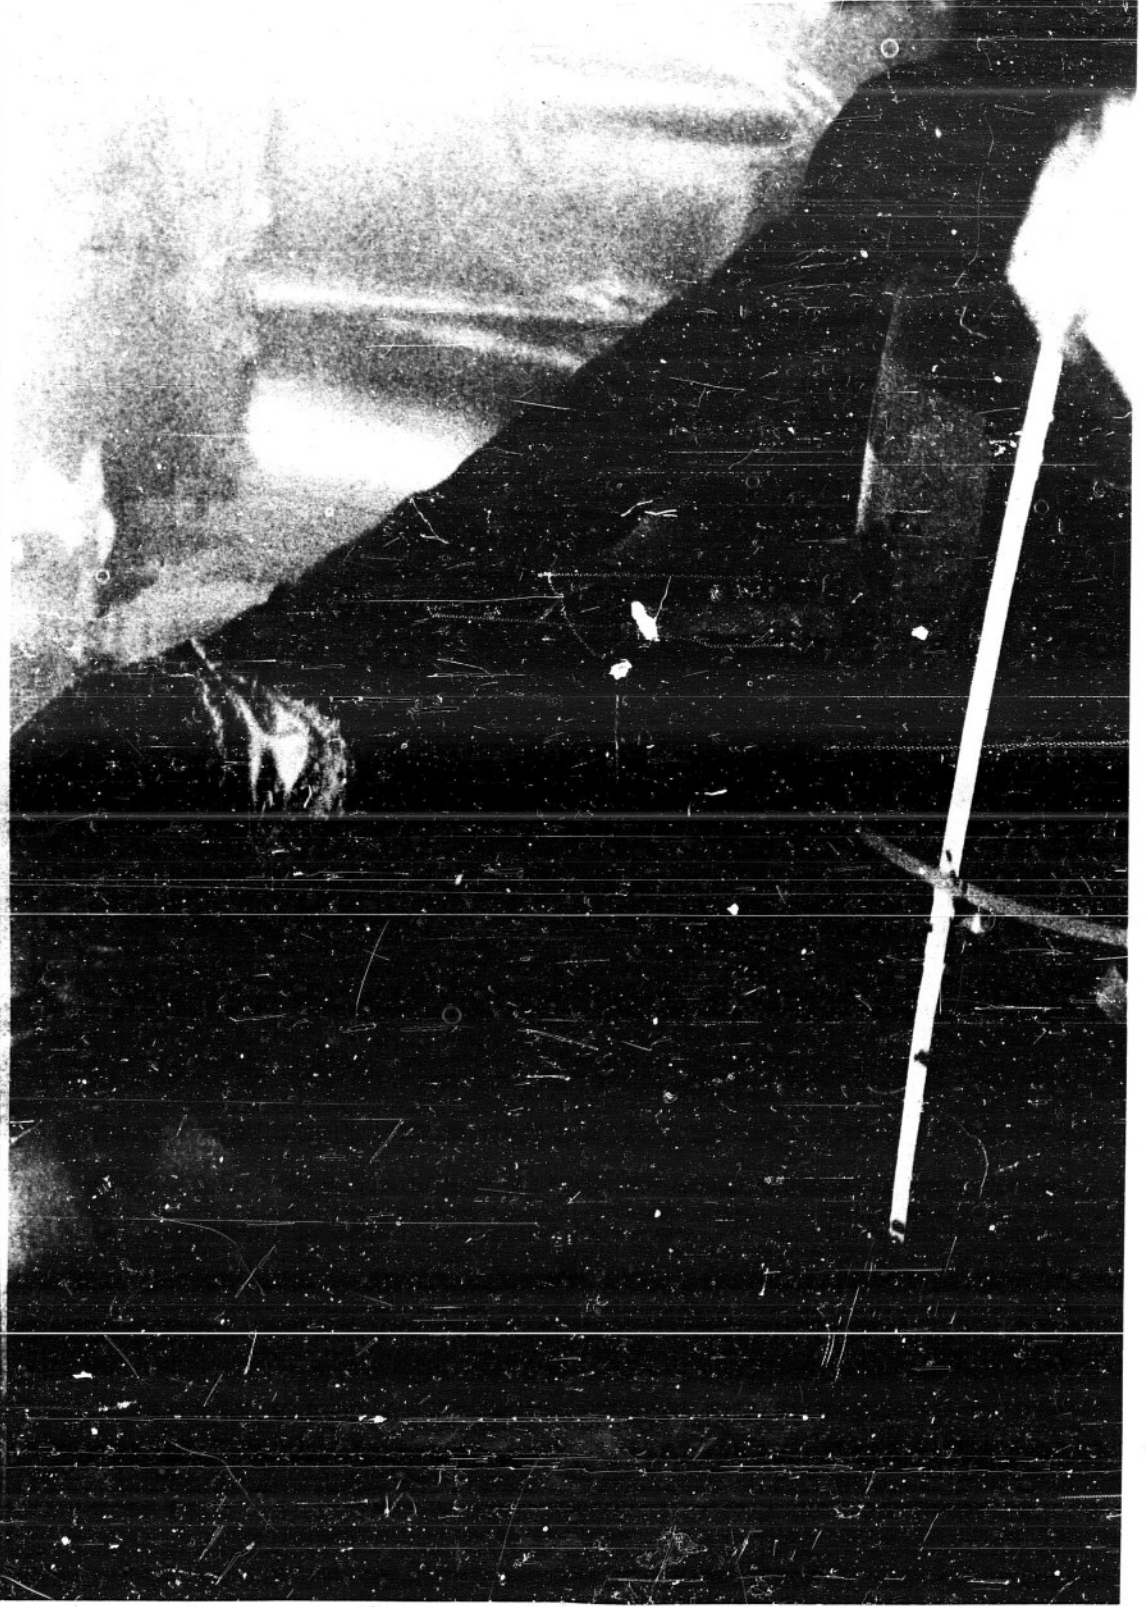
Figure 3

b. Very little difficulty was encountered in assembling the bomb sections as the winter clothing did not hinder the hammer motion required to drive the lock pins and fins in place. Figures 3 and 4 are views of the Ordnancemen assembling the bomb. The tape covering the lock pin pockets did not have to be removed before driving the pins in place; however, the tape covering the end of the nose and tail sections had to be removed before the nose and tail wind caps could be inserted. This tape appeared to be an unnecessary hindrance as it is inside the shipping ends during shipment and is difficult to remove with gloves on.

Bomb, Ex 14 Mod O (Fire-1000 lbs.) being assembled inside altitude chamber at -65°F.

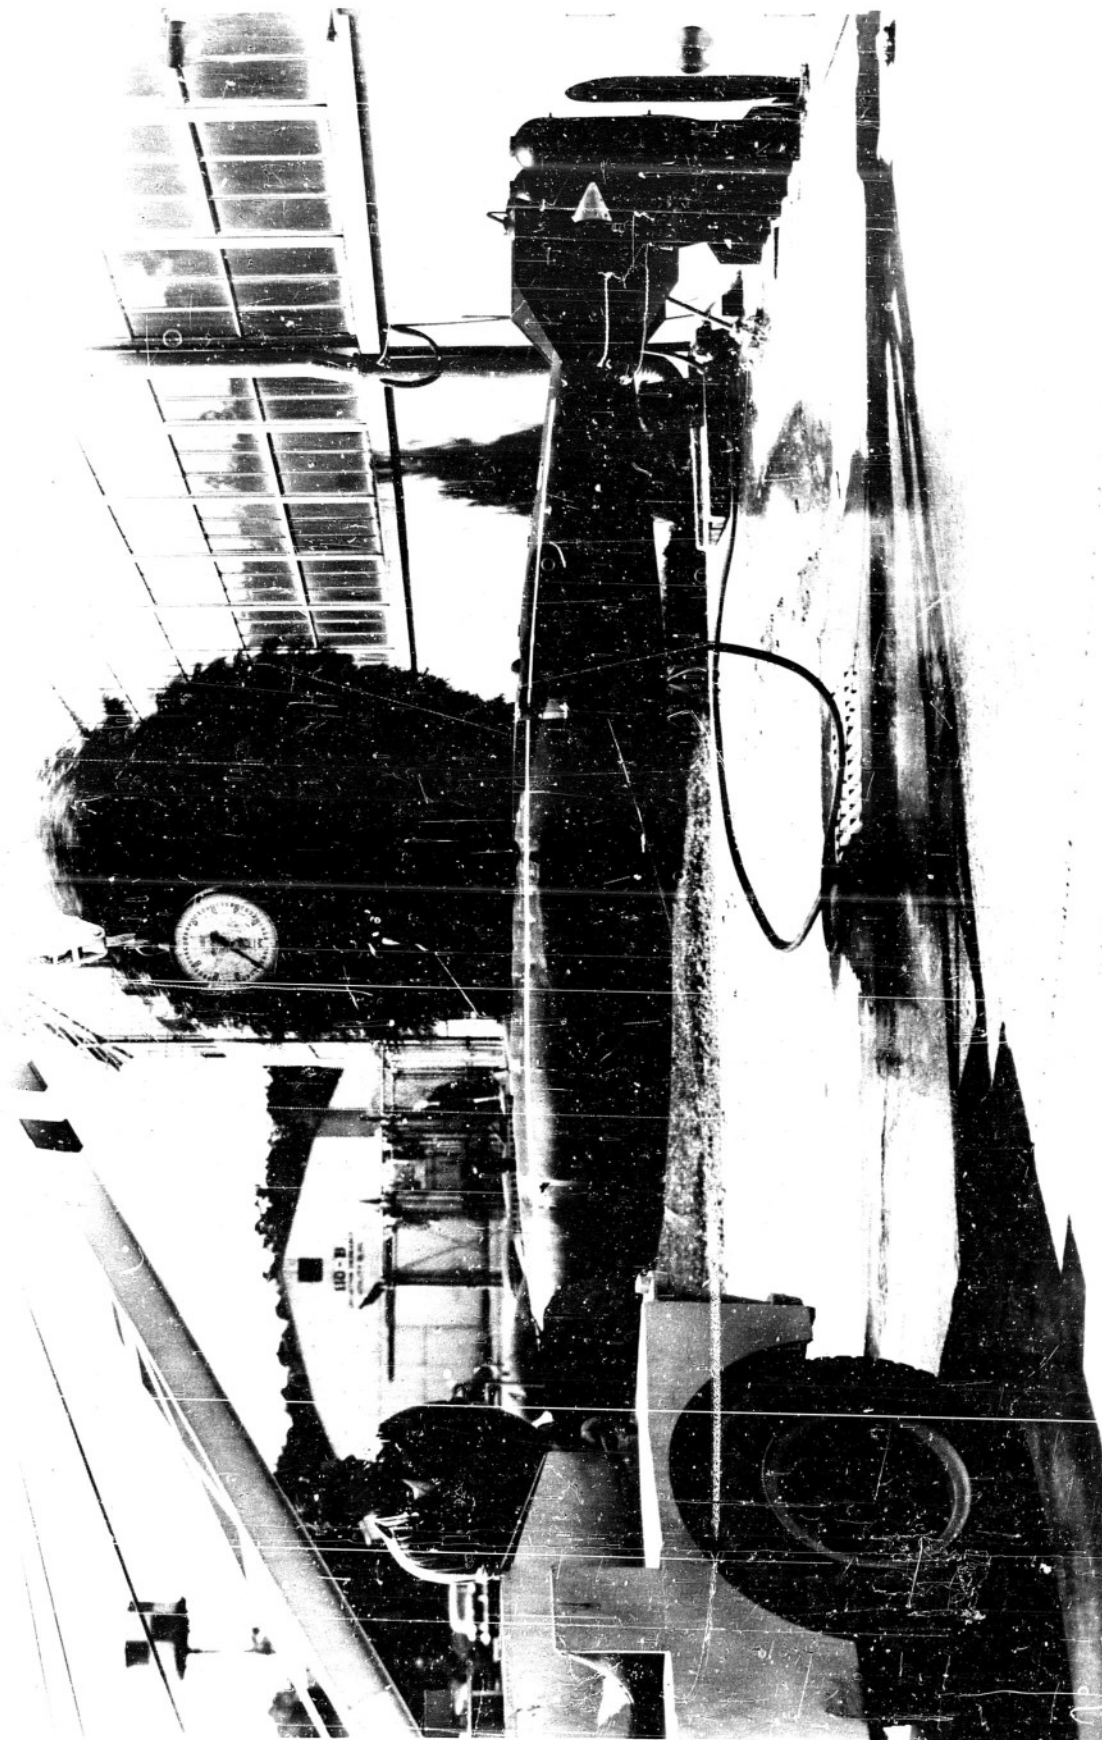
d. Because of the damage to the lock pin pockets, it was considered inadvisable to conduct a test on the sealing characteristics of the bomb inside the Altitude Chamber. The bomb was removed from the chamber, allowed to return to ambient temperature, and filled with water. When the bomb was full, it leaked 130 lbs of water in five (5) minutes, or approximately three (3) gallons per minute. Figure 5 shows the water leakage with the bomb half full and Figure 6 shows the leakage at the forward joint with the bomb full. During this portion of the test, the drive pins were checked for tightness and it was found that five (5) of the pins securing the tail section were loose and could easily be withdrawn. Measurements of the drive pins were made and it was discovered that the removable type drive pins were .020 to .025 inches thinner than the non-removable type normally supplied. The drawings specified a

CONFIDENTIAL  
SECURITY INFORMATION  
17 April 1953  
Bo. Ex. 14 Mod 0 (Fire-1000 lbs.). View shows water leakage with bomb half full.

- a. The present bomb not be assembled at temperatures below -20°F.
- b. The present "O" ring seals and filler cap seals be made of a material that is flexible and will withstand shock at -65°F.
- c. The tape covering the end of the nose and tail sections be left off.
- d. Leak tests be conducted on a bomb assembled at room temperature and stored at -65°F.

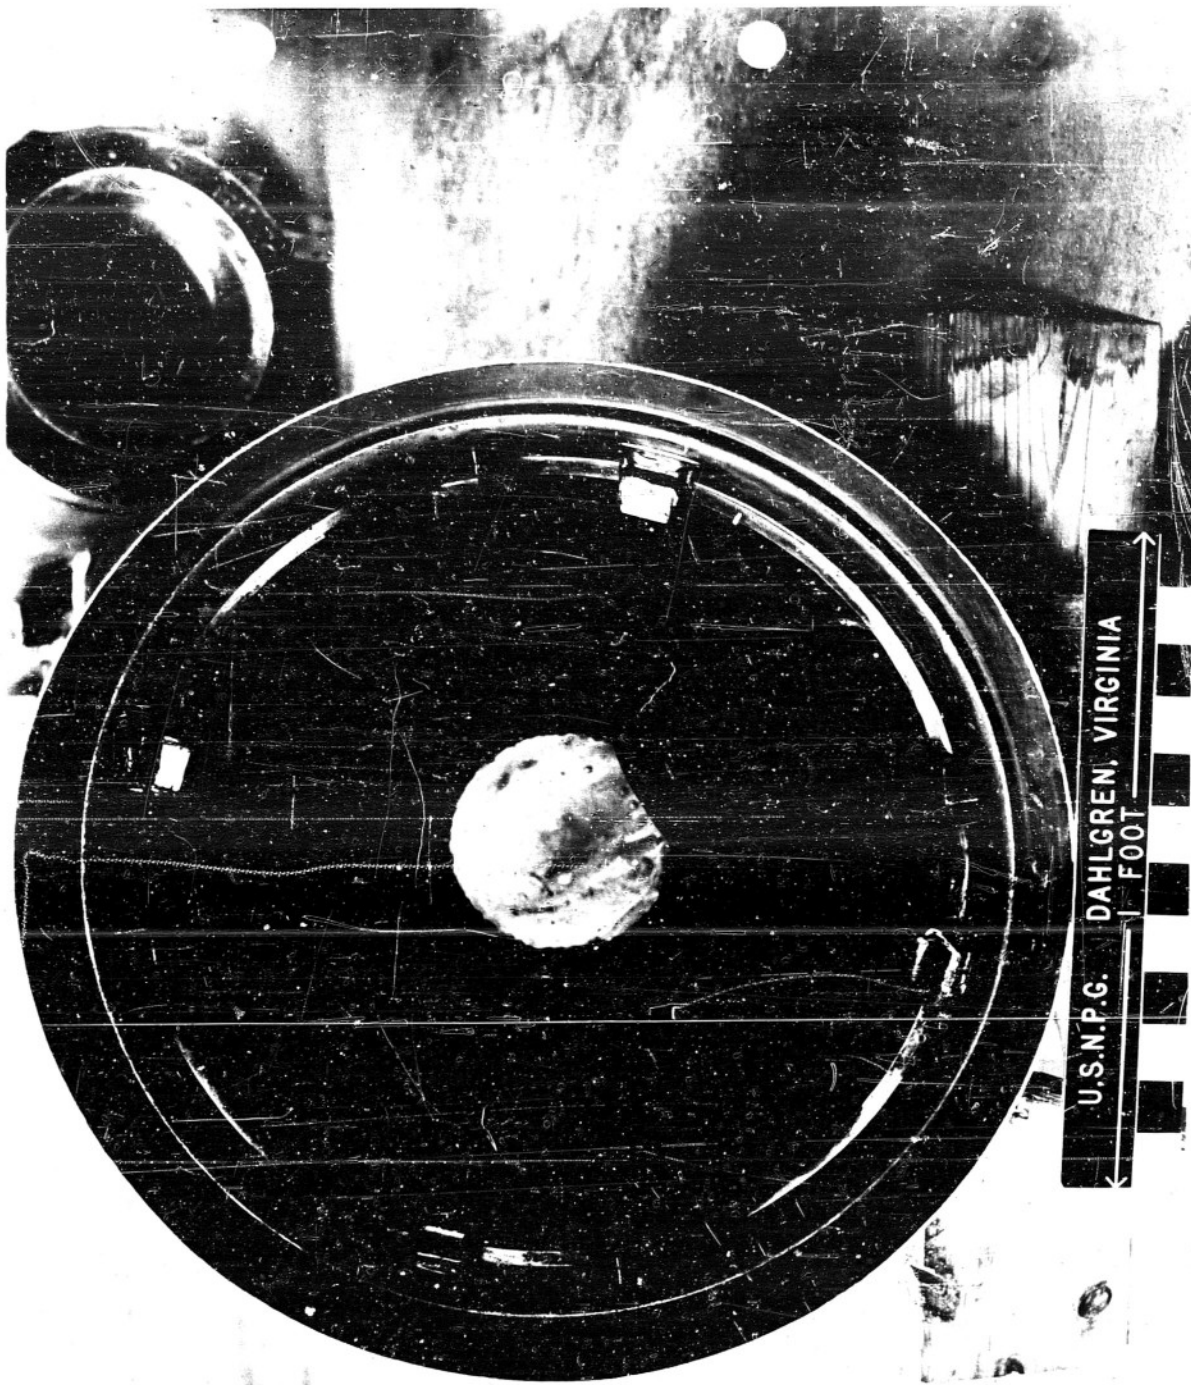
Figure 7

the bomb at this time revealed that there were pieces of the drive pins laying inside the bomb. The Ordnancemen stated that they could not tell when the pins had bottomed in the lock pin pockets and it was evident that the removable pins had broken through the pockets and in some cases the pins had also broken. The removable pins are approximately 5/8 of an inch longer than the standard pins and are thus longer than the pockets are deep.

slot  $.245^{+.000}_{-.010}$  inches wide in the pocket, whereas the removable type pins were only .235 to .240 inches thick. Thus there exists the possibility of a no interference fit. This may have been designed to facilitate removal of the pins; however, under the conditions the bomb was assembled, it is felt that this materially contributed to the fracturing of the pockets by the pins striking the bottom without any side resistance. Figures 7 and 8 show the damaged pockets.

NF 33459  
E-1b, Ex 14, Mod 0 (Fire-1000 lbs.). View shows damaged pockets in nose section.

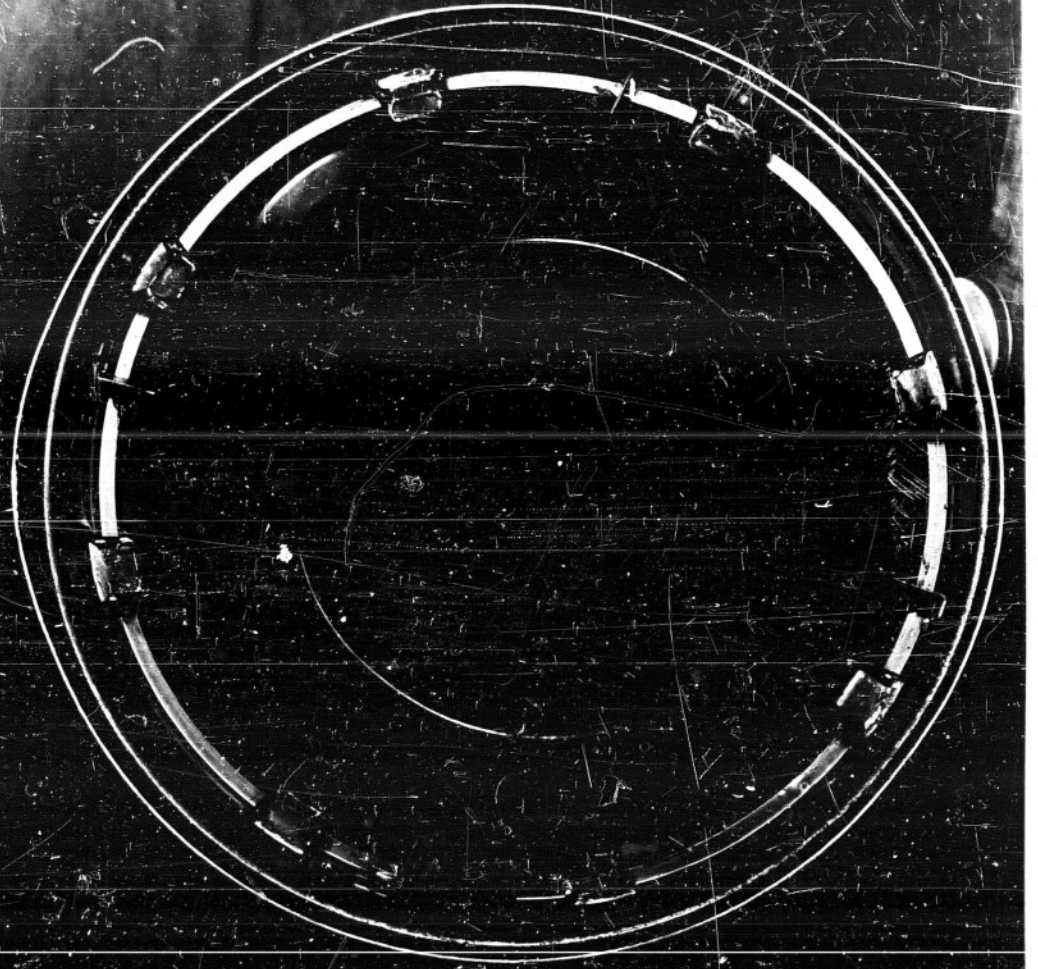
View shows damaged pockets in after section.

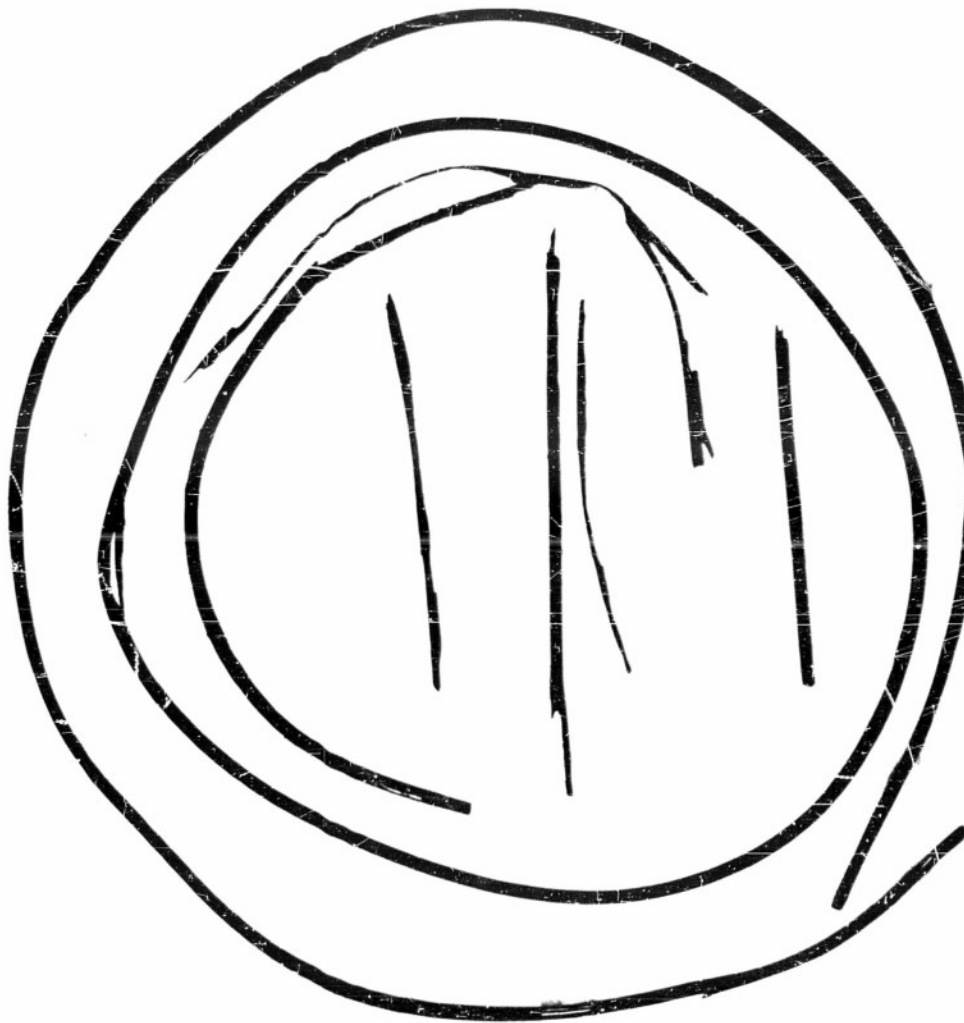
e. At the conclusion of the water tight integrity test, the bomb was cut open and the circumferential "O" ring seals removed and inspected. As shown in Figure 9 the seals suffered considerable damage and would not have held water. It could not be determined what portion of the leakage reported in the preceding paragraph was caused by the damaged "O" ring seals as the pockets and seals are adjacent. Portions of these "O" ring seals were subjected to a simple bend and hammer test at various temperatures. It was found that the seals could withstand bending at -35°F and would fracture at -40°F. In addition, it was found that they would withstand hammer blows at -10°F and would fracture at -15°F. Inasmuch as the "O" ring seals are not hit directly in assembly, it is felt that they would withstand assembly at temperatures down to -20°F.

- a. This bomb can be assembled almost as fast at -65°F as it can at +80°F by trained Ordnancemen.
- b. The sealing of the bomb is unsatisfactory for service use when assembled at -65°F.

View shows damaged "on" ring seals.
